Comprehensive analysis of local corrosion degradation on austenitic pipeline

Abstract. Corrosion degradation was observed in a nuclear power plant spent fuel cooling system. A systematic and comprehensive investigation program was developed to reveal the root cause of the degradation. Series of corrosion tests, mechanical, microstructural and microbiological investigations were carried out. Also, simulations of the operating conditions and welding parameters were performed. Based on the results, the major contributors to the degradation process were identified and a possible degradation mechanism was proposed.

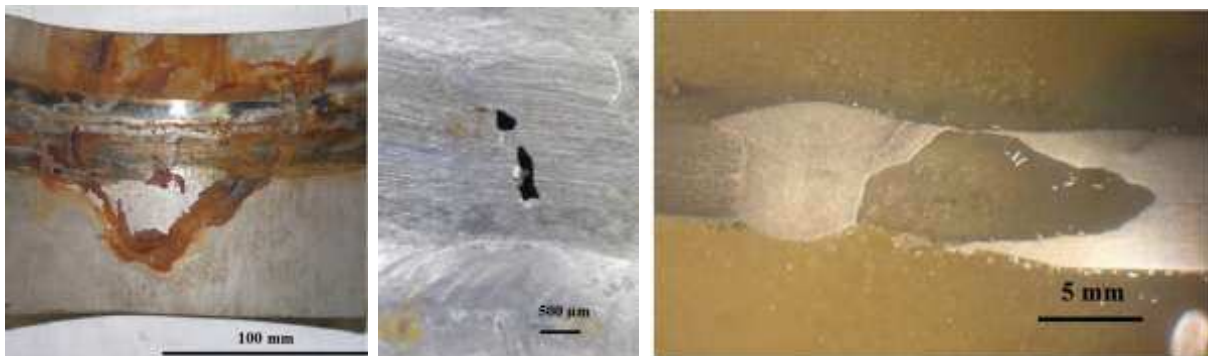
After 26 operating years, leakage was observed in the spent fuel pool cooling system at the Paks Nuclear Power Plant, Hungary. The cooling medium is boric acid with a concentration of $> 14.5 \text{ g}\cdot\text{dm}^{-3}$; and average temperature of $\sim 30^\circ\text{C}$. Two parallel loops operate alternately. Results of the immediate non-destructive examinations and subsequent comprehensive investigations made it clear that the leakage was caused by pitting corrosion on the inner surface of the cooling system pipelines. Some of the pits penetrated through the whole wall thickness. The structural material of the pipelines is Cr-Ni-alloyed, Ti-stabilized austenitic stainless steel (08Ch18N10T, nearly equivalent with steel 1.4541). The diameters vary from 100 to 300 mm; the wall thickness range is 6 to 10 mm. The pipes were laid down in concrete which made their investigations and subsequent replacements difficult and time consuming. *Figure 1* shows a through-wall pit detected by visual inspection and ultrasonic examination as well (left: corrosion products around a circumferential weld; middle: two pits after cleaning and decontamination; right: cross-section with the through-wall damage).

Figure 1. Pitting corrosion around the welded joint – pipe: Ø 219x10 mm (left: as is, middle: after cleaning, right: cross-section with the inside down)

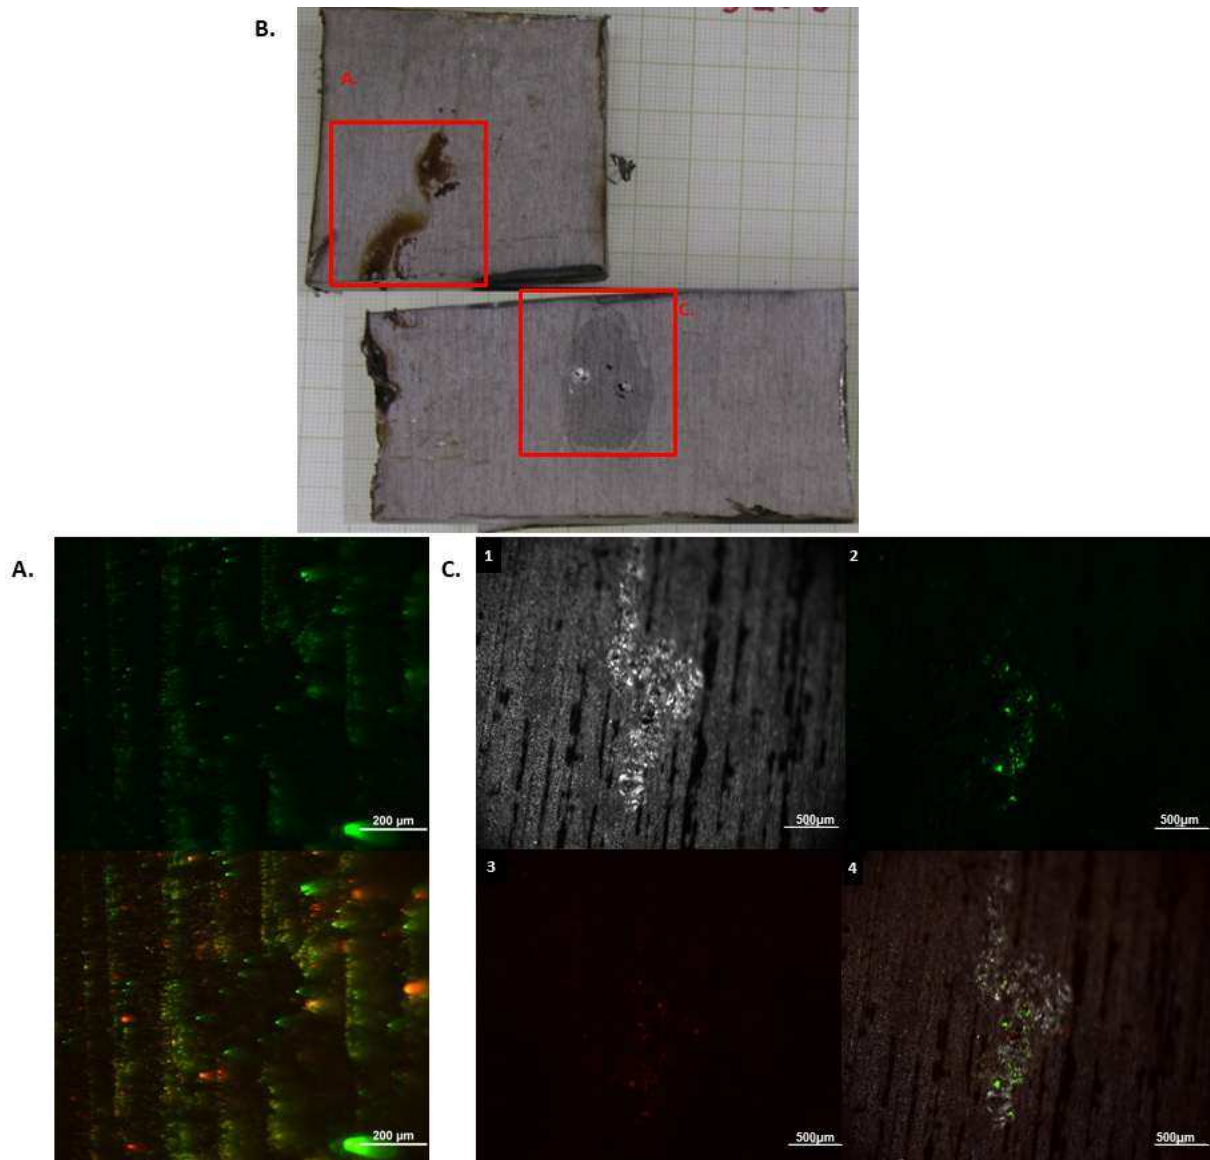
3.1.1. Effect of microbes on the corrosion phenomena. Over a two-year period, we were monitoring biomass changes in the bulk medium and found that most of the time the biomass was in the range of 10^2 - 10^3 ME·mL⁻¹, sometimes increasing up to 10^4 ME·mL⁻¹ (ME = microbial equivalent, cells). Next generation sequencing of the bulk medium revealed that the majority of the microbes is *Ralstonia pickettii*, a mixotrophic species viable in ultrapure water [2, 3]. It can live in an autotrophic manner by using only H₂ as a sole source of energy and CO₂ as the sole carbon source. It is known to produce extracellular polymer material, a matrix needed for biofilm development. The sequencing revealed members of the *Desulfobacteriaceae* and *Desulfovibrionaceae* family, members of the *Burkholderia* family, the *Sediminbacterium* genus that have been implicated in iron oxidation [4], as well as the acid producing *Acinetobacter* genus [5] that has been shown to be a pioneer bacterium in biofilm development [6, 7]. Although the amount or the type of microbes present in the bulk fluid does not represent microbes on the surface, the results suggest that *Ralstonia pickettii* together with other *Ralstonia* species might initiate biofilm development in the presence of boric acid. Biological activity reaction test (BART) [8] performed on corrosion products collected from the bottom of the pipes revealed the presence of both iron oxidizing and iron reducing bacteria, heterotrophic micro-organisms, slime forming bacteria, as well as acid producing bacteria. Sulfate reducing bacteria were not detected. Corroded areas were analyzed by fluorescence staining to visualize live and dead cells inside the pit after cleaning (*Figure 2C*) and on corrosion deposit (*Figure 2A*).

Figure 2. Fluorescence staining of corroded stainless steel.

A. Live cells (upper) and merged image (lower) of corrosion products; B. The corroded surface; C. (1) bright field image, (2) live cells, (3) dead cells, (4) merged image

The pit had a shiny metallic surface (*Figure 2B*: lower picture) suggesting an active corrosion mechanism, and live/dead stain revealed microbes inside the pit but not outside (*Figure 2C*).

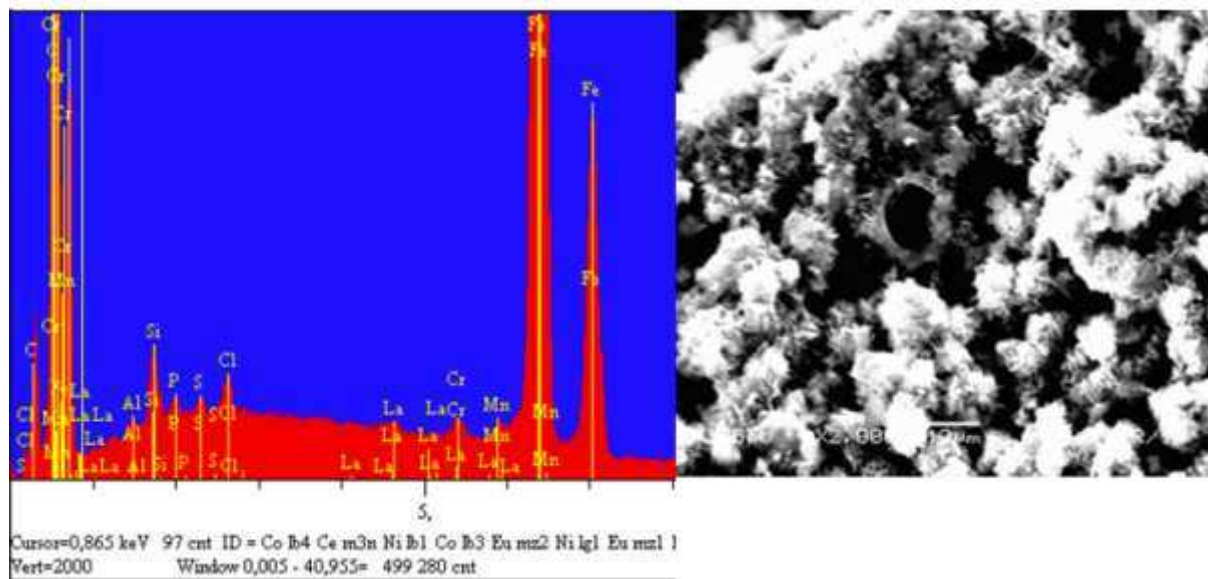
A SEM/EDX analysis at another corrosion site revealed phosphorus, sulfur and carbon that may be indicative of microbial presence at the site of corrosion. Left picture (SEM) in *Figure 3* shows the pit and the porous corrosion product around it; on the right side the EDX spectrum can be seen.

Figure 3. Porous corrosion product (inset) and its EDX-spectrum

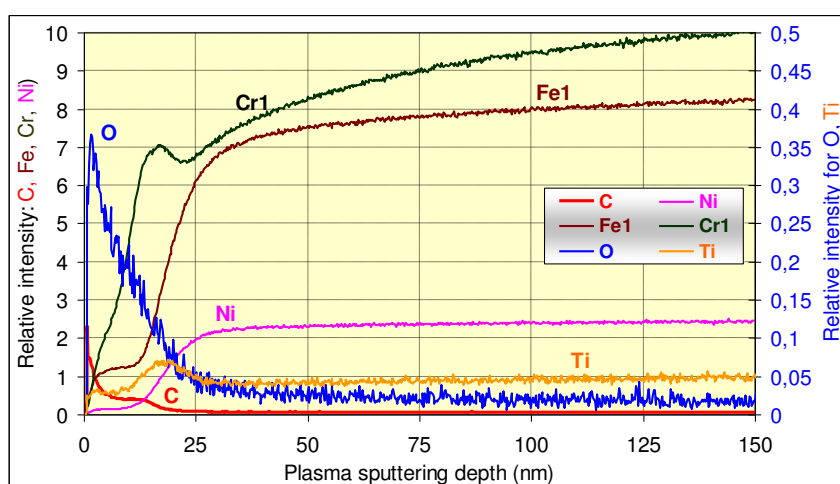
The glow discharge optical emission spectroscopy (GD-OES) is capable of measuring the layer's thickness and determining its tentative chemical composition. In *Figure 4* the GD-OES intensity measured on the transition to HAZ can be seen. First of all, the oxygen content and the distribution of Ni, which has a low inclination to migrate can indicate the boarder of the oxide layer with the thickness being approximately 10 nm. In the middle of the HAZ the thickness approaches 50 nm while on the normal surfaces the passive layer thickness does not exceed 3-4 nm. Intensity of Fe, Cr and Ni

Figure 4. GD-OES intensity of various elements as a function of the sputtering depth, on clean surface

reaches the value characterizing the base material at this depth. The oxide layer's composition is detrimental from the corrosion's point of view because it contains less Cr than the normal passive layer

and has a less beneficial Cr-oxide/Cr and Cr/Fe ratio. On the other hand, during the evolution of the thicker oxide layer more Cr will be detracted from the area beneath the scale than in the case of a normal passive layer.

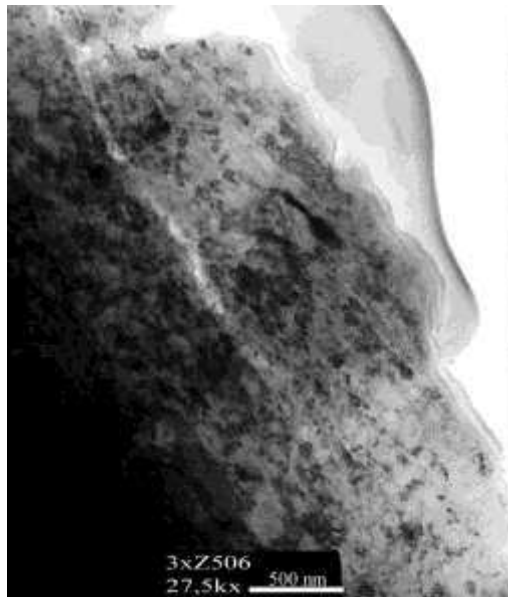
Similar oxide layer thickness could be identified by transmission electron microscopy (TEM). On a segment perpendicular to the surface, the glue indicates the outer surface of the sample, see *Figure 5*, and immediately under it an amorphous oxide layer is visible with a thickness of 50–100 nm.

Figure 5. TEM picture of the welding scale covered thin foil

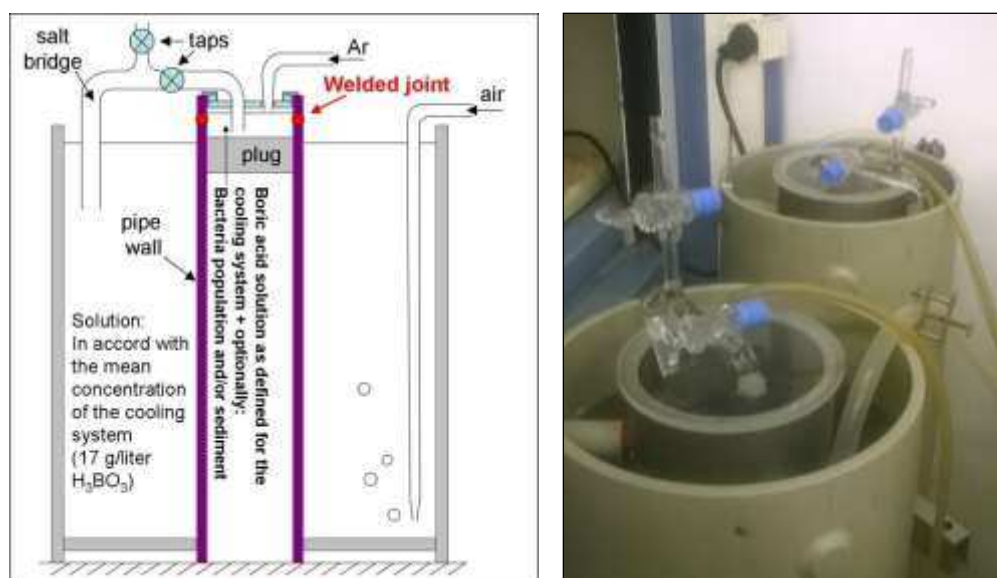
- Long term operation (46 days) of differential aeration cells with large cathode/anode surface ratio confirmed the extreme corrosion sensitivity of weld produced without proper protection. These samples showed approximately ten times faster corrosion velocity than the samples without welds.
- Also, simulation of differential aeration in anaerobe environment revealed biofilm development on surfaces of solid materials. It occurred even in the presence of boric acid. A biofilm is considered as a potential initiation factor for microbiological corrosion degradation.
- On the weld root side of the specimens, the initiation stage of pitting corrosion could be observed, as well as indications for tuberculum development were found. It is to be emphasized that these degradation processes developed in a relatively short time.

Figure 6. Setup of the differential aeration model (left) and the equipment (right)

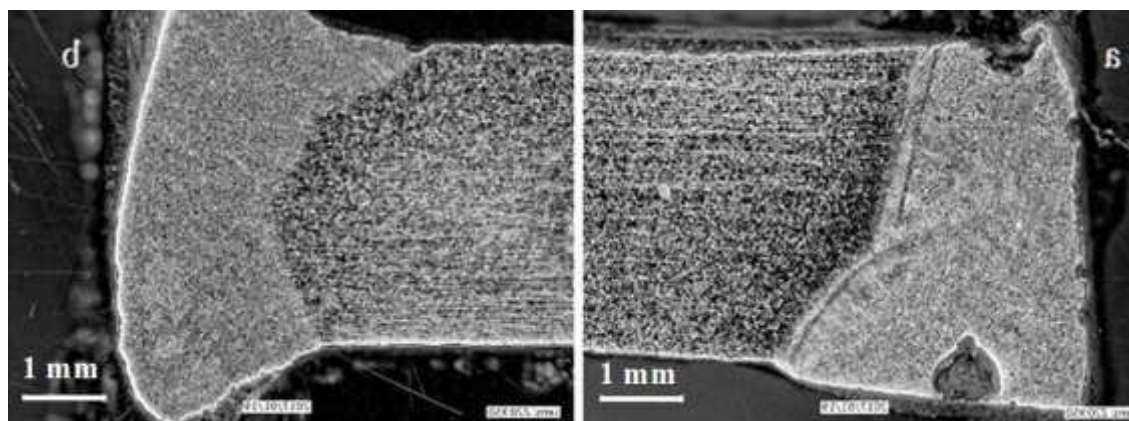
intensive degradation supports the hypothesis that root protection has significant impact on the corrosion sensitivity of the welds. *Figure 7* shows the sample welded in accordance with WPS but without root protection. Pits can be seen both on the weld face and at the root in the sample tested at 50°C. The latter demonstrates the influence of the temperature. Significantly more corrosion products were formed when the solution contained MIC bacteria compared to a non-MIC environment.

Figure 7. Test at 50°C, in 3.6 % FeCl₃ (a); at room-temperature, in 6 % FeCl₃ (b)
