Non-Destructive Evaluation and Damage Determination of Fiber-Reinforced Composites by Digital Image Correlation

Abstract

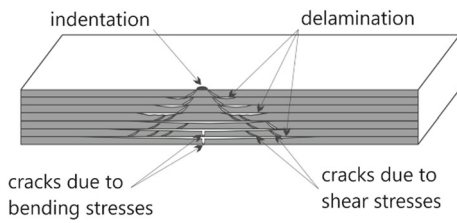
Fig. 1 Typical BVID damage [6]

the structure’s maximum load capacity, which was predetermined in the design stage. These defects originate from various failure modes co-occurring in the layered structure, such as matrix crack, matrix-fiber debonding, fiber rupture, and delamination [1]. For example, a typical phenomenon occurring in FRPCs is barely visible impact damage (BVID), usually caused by hits during operation. During the typical BVID, the damage in the outer surface of FRPC can hardly be identified, while, in fact, the damage inside the structure can be much more serious. Thus, the defect continuously grows in a conic or inverse conic shape from the place of impact across the thickness of the structure (Fig. 1), depending on the laminate thickness. This can cause delamination, fiber breakage, and unwanted shear stress inside the FRPC. All these internal defects can significantly reduce the load-bearing capacity of a structure even though, visually, the structure is intact [2]. The complex character of FRPC failure makes lifetime prediction difficult or even impossible [3, 4]. However, this is unacceptable in a safety-critical application [5].

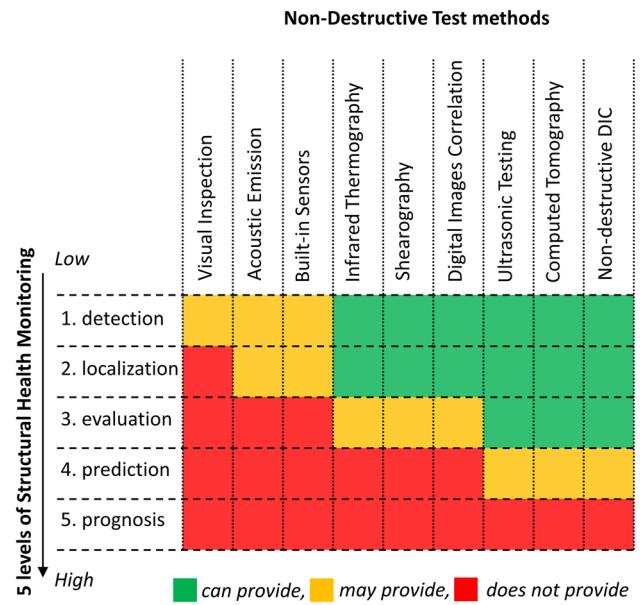
Fig. 2 Classification of test methods based on which level of SHM they can provide about barely visible impact damage

There are many options for classification methods of SHM [20, 21], for example, the working mechanism of the method, the time of the test, the price of the equipment, the location of the sensors, etc. However, in this paper, we classify the common NDT test methods depending on what level of SHM (Fig. 2) they provide about BVID.

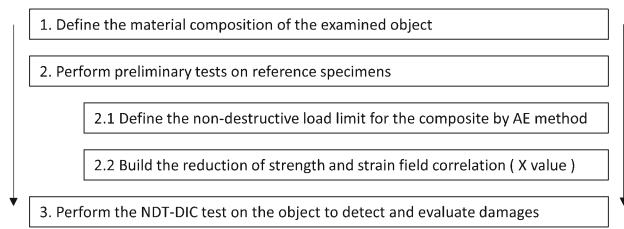
Fig. 3 The general flowchart of the proposed NDT-DIC method

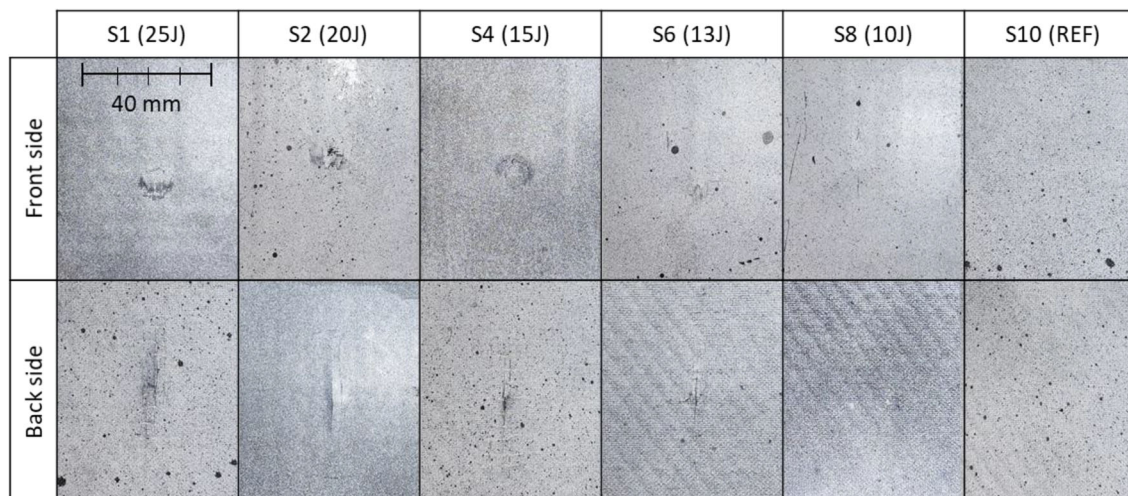
Table 3 Characteristic forms of damage

hit with different impact energies. The specimens that were hit with a load between 13 and 25 J showed hair-thin cracks along the length of the reinforcement on the back sides of the specimens. These were matrix cracks between rovings in the outer layers. Table 3 visually presents the characteristics of different damages.

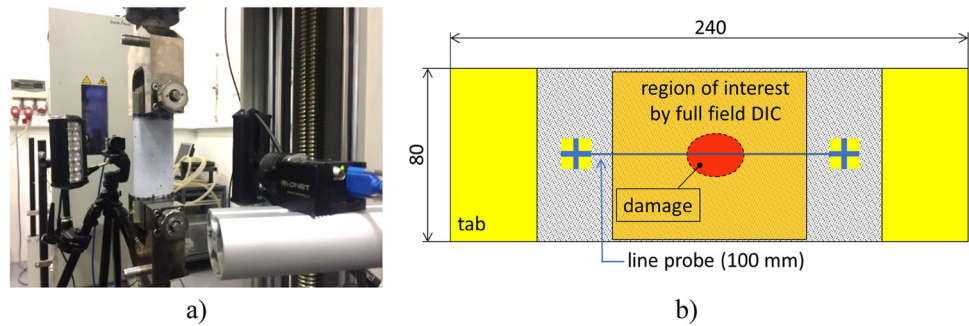
Fig. 5 **a** The setup of IRT, **b** schematic representation of the specimen

We localized and analyzed the failures in the specimens by IRT with a FLIR A325sc (FLIR Systems, Wilsonville, USA) infrared camera (Fig. 5a). IRT was calibrated with the camera-object distance of 300 mm, a room temperature of 24 °C, and a humidity of 50%. The reflected temperature and emissivity were 24.3 °C and 0.95, respectively. The specimens were heated up to 75 °C in a Heraeus UT 20 (Heraeus, Hanau, Germany) oven before IRT. This temperature is low enough and has no adverse effects on the polymer matrix based on preliminary DSC and DMA tests. The IRT data were collected with a frame rate of 5 Hz. FLIR researchIR software was used to collect and analyze the data.

3. We set up a sampling line across the defect and analyzed the temperature distribution along this line at certain moments of time. The obtained temperatures were regarded as the temperatures of the defects (Fig. 5b).

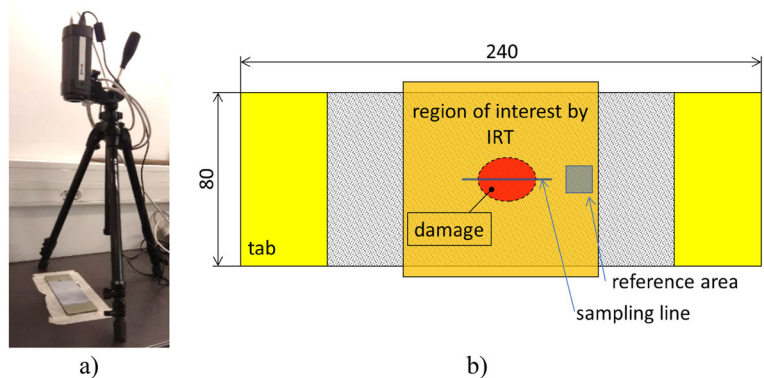
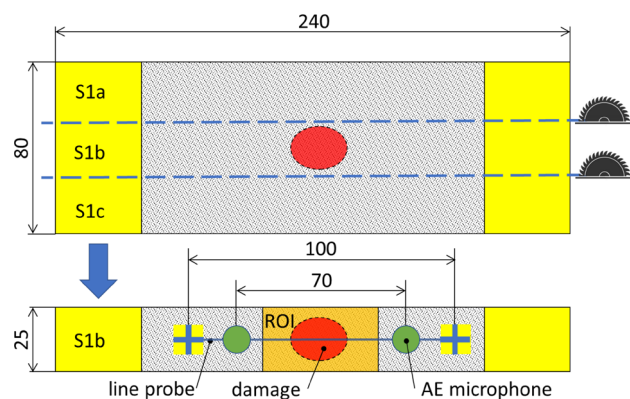
Fig. 6 Preparation of 25 mm wide specimens and their test setup

After the 80 mm wide specimens (S1–S10) were tested with DIC and IRT methods, they were further cut into 25 mm wide specimens. Thereby from one 240 \times 80 mm FRPC specimen, we cut three specimens with the sizes 240 \times 25 mm, which are the standard sizes for specimens used in tensile tests (Fig. 6). In such a way, we obtained one specimen with the damage in the middle and two specimens where the internal damage can possibly but not necessarily exist.

We tested the obtained specimens by DIC. The DIC setup and its settings are identical to the settings described in Subchapter 2.2.1. Additionally, in this experiment, we added AE to compare the results obtained by the DIC method with those delivered by the AE method and to prove that the applied load was still in the NDT range of the specimens. The AE microphones were mounted on the specimen by plastic clips. The AE signals were recorded by a Sensophone AEPC-40/4 (Gereb es Tarsa Ltd., Budapest, Hungary) device with

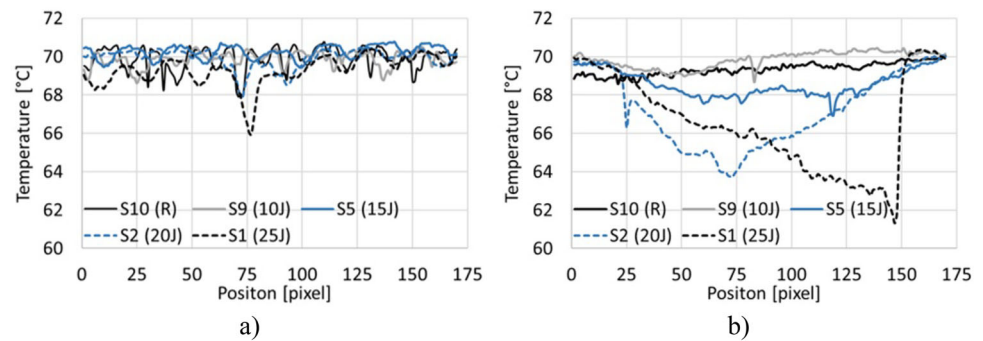
Fig. 7 Localizability of different levels of BVID on the front side (a) and the back side (b) by IRT

A significant difference was found in damage detectability for the two sides of the same specimens. The diagrams in Fig. 7 show the temperature distribution along the sampling line when the temperature of the reference area is 70 °C. The lower peaks of the temperature curves identify where the defect is localized. For the defects created with an impact energy of 20 and 25 J, we can observe clear peaks of the temperature curves for the front side of the samples (Fig. 7a). For damage created with an impact energy lower than 20 J, the

peaks of the related temperature curves are almost invisible. On the back of the specimens, the damage created with 15–25 J is clearly visible, and even 10 J damage can be detected if the sampling line is placed carefully (Fig. 7b). The main reason for this difference comes from the nature of BVID. The front side, where the tip of the falling dart hit the specimen, received a compression load, which can deform or even crack the matrix, but it does not significantly influence the IRT image. Contrary to this, the back side of the specimen deforms much more than the front side due to the tension caused by the falling weight. Therefore, the back side of the sample can exhibit fractured rovings and/or delamination between layers. We found out that above a critical impact energy, which was 15 J in this test, an open crack appeared on the back side of the specimens. Open damage has a higher free surface and, therefore, can cool down faster than the undamaged parts of the specimen. This is why it shows cooler spots in the temperature map.

The deviation of the temperature curves which belong to the front side of the samples (Fig. 7a) originated from the characteristics of the manufacturing process. Surface irregularities cause changes in temperature, which IRT shows. Moreover, IRT is sensitive to environmental conditions, which can cause asymmetric cooling. Figure 8a shows the temperature curves from both sides of the S10 reference specimen, where we can see the effect of surface irregularities and asymmetrical cooling, which are illustrated with the deviation and incline of temperature curves. Figure 8b shows a position of a sampling line and reference widow on an S1 specimen's back side. In fact, the position of the virtual sensor, which depends on the operator, also greatly influences the results.

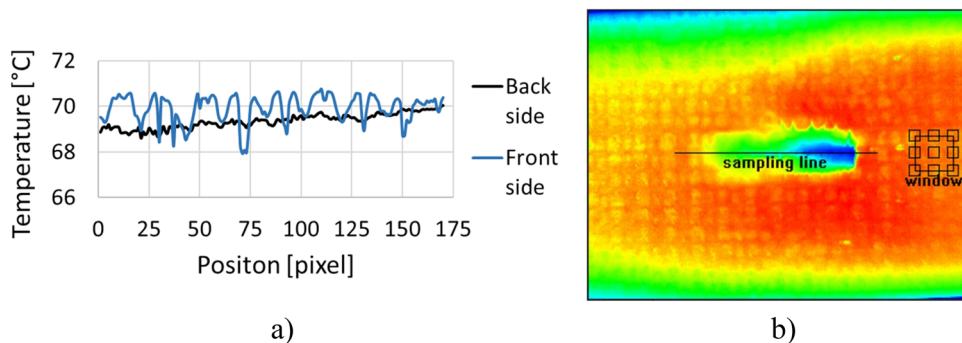
Fig. 8 **a** temperature distribution of the both sides of the reference specimen at 70 °C **b** field of view of IRT and the position of sampling line and window

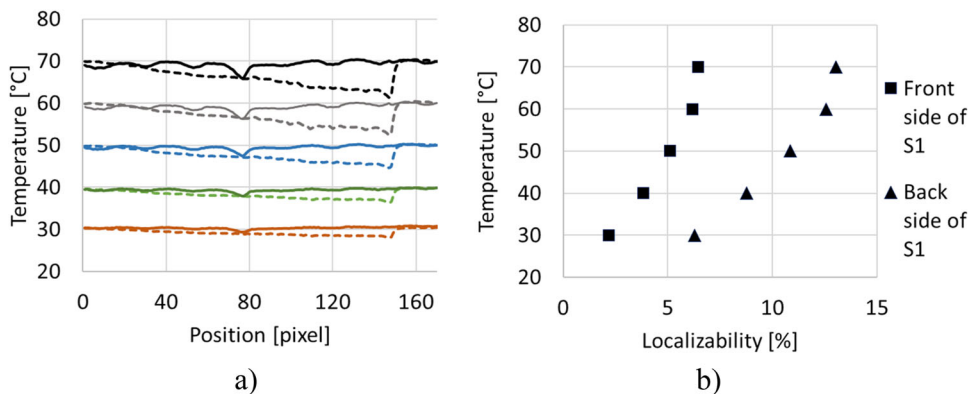
Fig. 9 **a** graphical and **b** specific representation of localizability reduction at different reference temperatures

We also examined the influence of the different reference temperatures on the IRT results. While the sample was cooling down, we recorded the IRT results for different reference temperatures and analyzed the sensitivity of the IRT method as a function of temperature. We found that lower temperature makes it more difficult to detect damage (Fig. 9a). To characterize the effectiveness of the IRT method at different

where μ_{IRT} is the coefficient of effectiveness of IRT, T_{ref} is the reference temperature of the sample, T_{min} is the minimum temperature on the sampling line. We summarized the results of the effectiveness of IRT in Fig. 9b. We observed that the lower the reference temperature, the worse IRT can localize the defect in a composite. These numerical values are particularly important because they are required when automated evaluation is programmed.

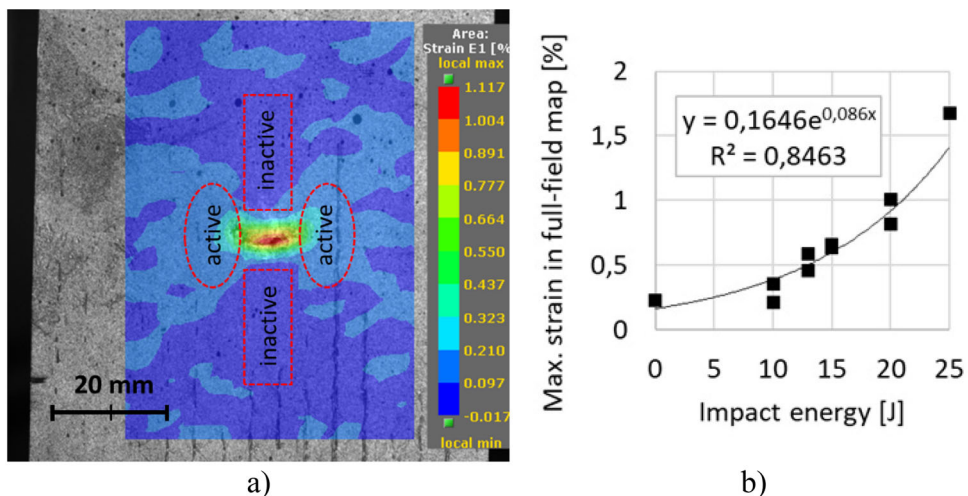
Fig. 10 A typical principal strain map of the composite sample under load **(a)** and the dependency of the maximum strain in the map on the impact load that created the damage **(b)**

We examined the samples under tensile load by DIC. We didn't break the specimens in this phase. We only loaded them to the strain limit of 0.15% and built a correlation between the maximum principal strain observed with full-field DIC and the impact load, which was used to create the damage (Fig. 10b).

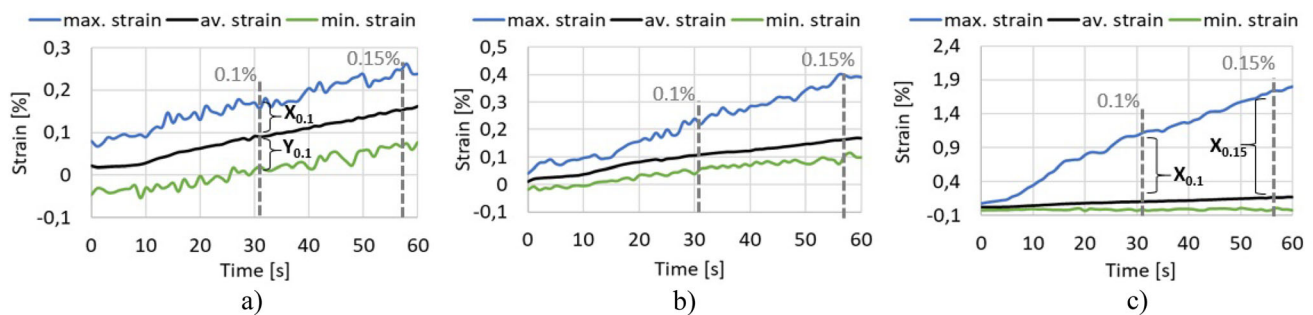
Fig. 11 Strain curves of specimens from the DIC full-field map **a** S10, **b** S5, **c** S1

“reference sample” or S10). We found that for the reference sample, the progression of ϵ_{min} and ϵ_{max} , is symmetric to ϵ_{av} (Fig. 11a), and the standard deviations of the measured values are around 0.1% strain. Contrary to this, the distribution of ϵ_{min} and ϵ_{max} for the samples with the defects (S5 and S1) is asymmetric to ϵ_{av} (Fig. 11b, c). The difference between ϵ_{max} and ϵ_{av} increases with the size of the defect. Thus, the diagram of S1 (25 J) shows a very high strain compared to the average.

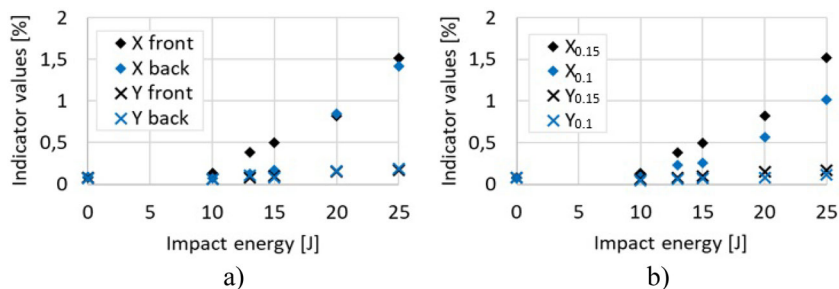
Fig. 12 a Indicators $X_{0,15}$ and $Y_{0,15}$ from both sides of the specimens which characterize the damages caused by different impact energy, **b** comparison of indicators X and Y obtained at different load levels

Figure 12a shows the correlation between the presented $X_{0.15}$ value and the impact energy on both sides of the specimens. This diagram shows that the damage is detectable on the front side from 10 J impact energy, although the X values from the back side are close to the references. In the case of 20 and 25 J impact energy, the X values indicate the damage with similar efficiency on both sides. In a future test, this diagram can help us to predict easily how big the impact energy which damaged the examined object was.

Figure 12b shows the effect of the different strains on the indicators. The values of the indicator significantly increased when the load on the specimen was increased by 0.05%. It also means that the increasing load makes it possible to find a smaller defect in the structure. However, the test range should be kept quasi-non-destructive, so a control method is needed which can define a limit to our tensile test. It seems logical to choose AE for this.

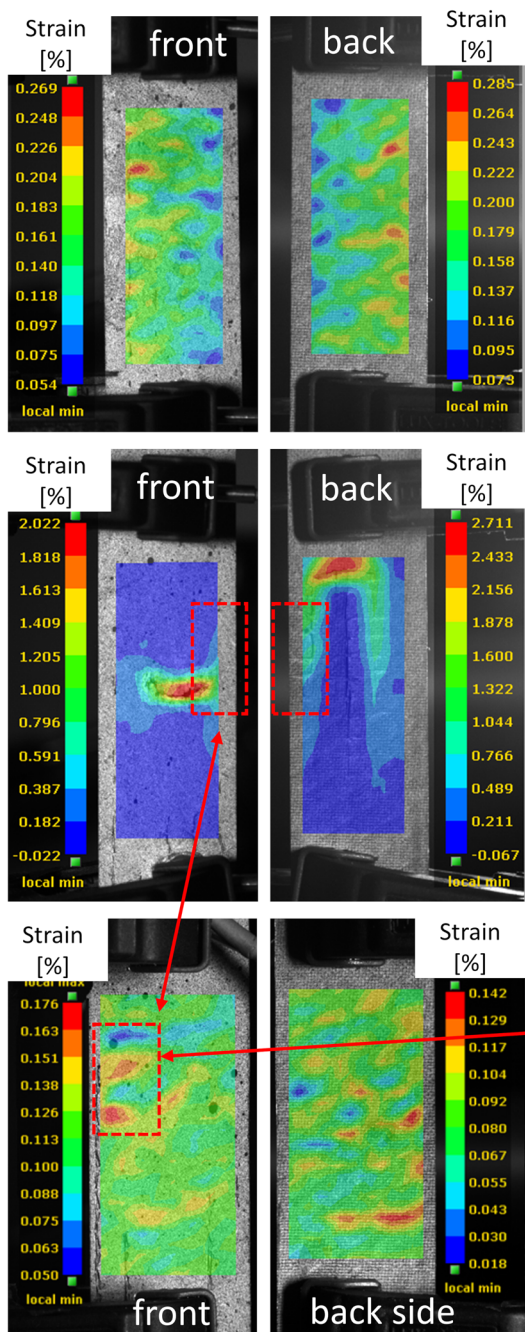
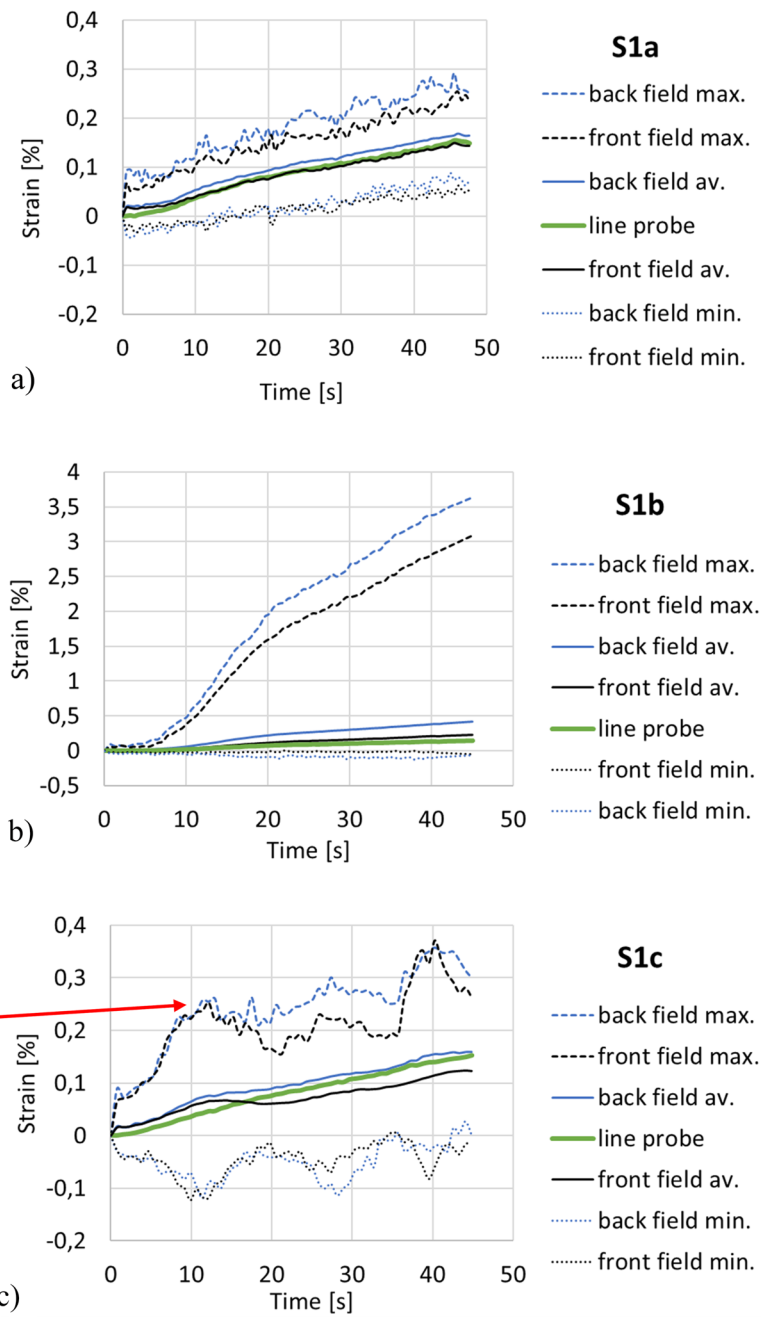
Fig. 13 Strain full-field maps and strain curves of specimens **a** S1a, **b** S1b (25 J), **c** S1c

Figure 13 shows the strain maps of specimens S1a, S1b, and S1c when the total strain of the specimens was 0,1%. The S1b specimen, with the 25 J impact damage, shows a significantly different pattern in the strain map than the others. The

background of the strain map of S1b is mainly blue ($\sim 0.07\%$), which means that most of the specimen has very low strain compared to the damaged area, which is marked with yellow and red ($\sim 0.7\text{--}0.9\%$). This pattern does not change during the test, only the strain increases. S1a and S1c look like a usual reference specimen: green base ($\sim 0.1\%$) with random, continuously changing red and blue spots. It means that the specimen has an average strain with small locations that are overstretched or understretched. The strain curves can show more details, just like in the case of wide specimens. S1a shows continuously increasing strain, but the deviation and the symmetry indicate an undamaged structure, unlike S1b, where the maximum strain is much higher and continuously grows with the loading of the specimen. The strain field of specimen S1c is similar to that of S1a, but in the case of S1c, an alternation of maximum and minimum values can be observed on the curves. It comes from the red rectangular area of S1c, which shows the delamination in the specimen. At first, this area starts to show significant activity because of the load. Then most probably, the friction between the delaminated surfaces stops the further elongation of this part, so other undamaged parts start to activate, in other words, produce greater strain. When the elongation of the undamaged part reaches a critical point, the friction between delaminated layers ceases, and it presents high activity again. The falling weight generated this delamination, and the delamination spread to S1c from S1b. It is observable from the strain fields of S1b (red rectangles).

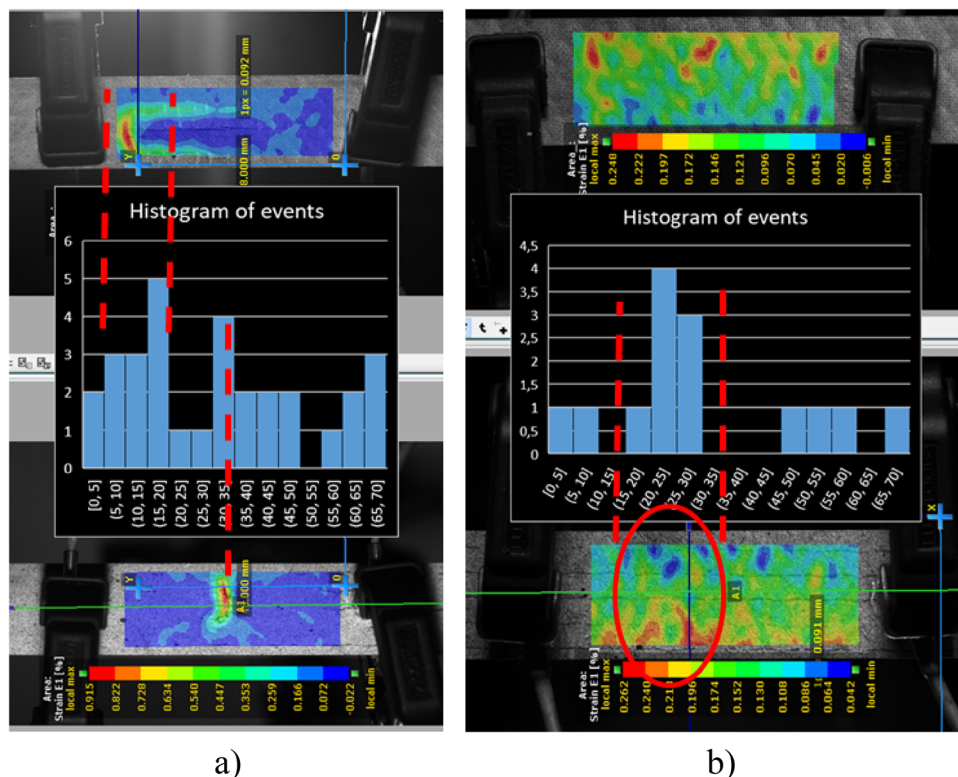
Fig. 14 AE linear localization of **a** S1b (25 J), **b** S10a (ref) specimens

The obtained frequency and amplitude values of AE events collected during the reference specimen's tensile tests did not show significant differences compared to the data collected during tensile tests of the impacted specimens. Therefore, AE provides little information about the damage and does not show what happened to the specimens. However, DIC can easily show the active zones of the specimen where the events come from (Fig. 14). In the case of S1b, the different peaks originated from different sides of the specimen.

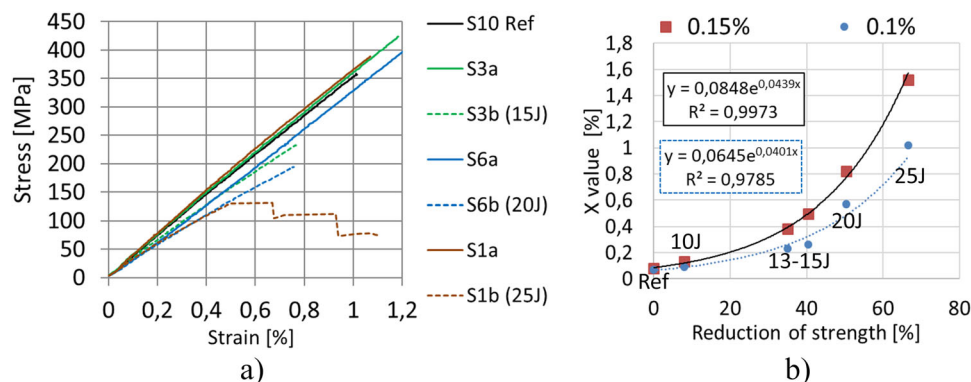
Fig. 15 Results of tensile tests **(a)** and the final correlation between X and the reduction of ultimate strength **(b)**

Averaging the values of strength of the reference specimens and of the undamaged specimens from the sides indicated with (a) and (c), we determined the reference ultimate strength. This reference strength was used for the calculation of the strength reduction of damaged specimens. Specimens with 10, 13, 15, 20, and 25 J impact damage show approximately 10, 37, 40, 50, and 65% reduction in ultimate strength, respectively.

The ultimate strength of specimens was obtained with a tensile test. We found a strong correlation between X from the first DIC test and ultimate strength reduction. Based on our method, the complete evaluation (position, area, severity) of any BVID is possible with the non-destructive DIC test in the future in a certain combination of materials and stacking sequence.
