# Manufacturing of composites with designed failure

G Zs Marton<sup>1,2</sup>, Á Fendrik<sup>3</sup> and G Szebényi<sup>1,2</sup>

<sup>1</sup> Department of Polymer Engineering, Faculty of Mechanical Engineering, Budapest University of Technology and Economics, Műegyetem rkp. 3., H-1111 Budapest, Hungary

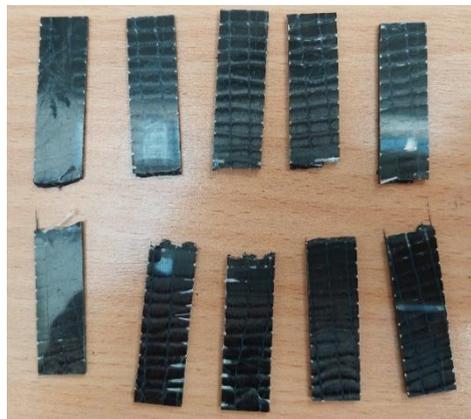
**Figure 3.** Reference specimens after the impact test.

Then, the failure mode and position were evaluated. The results show that the reference composites failed in a brittle manner along the line of the impact, as expected (Figure 3). For the composites containing PCL interlayer material, Figure 4 and Figure 5 suggest that the smaller thickness does not significantly affect either the fracture path or the mode of failure. However, the 0.8 mm thick interlayer material had a significant effect on both failure mode and position: two specimens failed by delamination, while for three specimens, the fracture path was increased, with failure occurring along the line of the interlayer material.

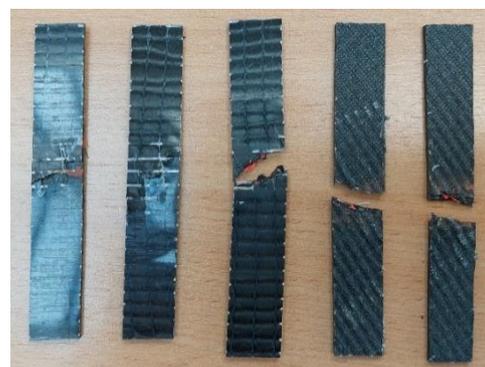
**Figure 5.** The specimens containing PCL interlayer material with a width of 2 mm and a thickness of 0.8 mm after the impact test.
