## WRINKLING AT THE FAILURE OF MEMBRANE STRUCTURES

Eszter FEHÉR, Dezső HEGYI, Marianna HALÁSZ, Péter TAMÁS

*A physical and a numerical model were worked out to examine the failure of a membrane structure. The wrinkling phenomenon was noticeable in some situations. This experiment leads to further questions: which are the most characteristic disposition parameters and how they set up the balance of the surrounding parts of the slack regions.*

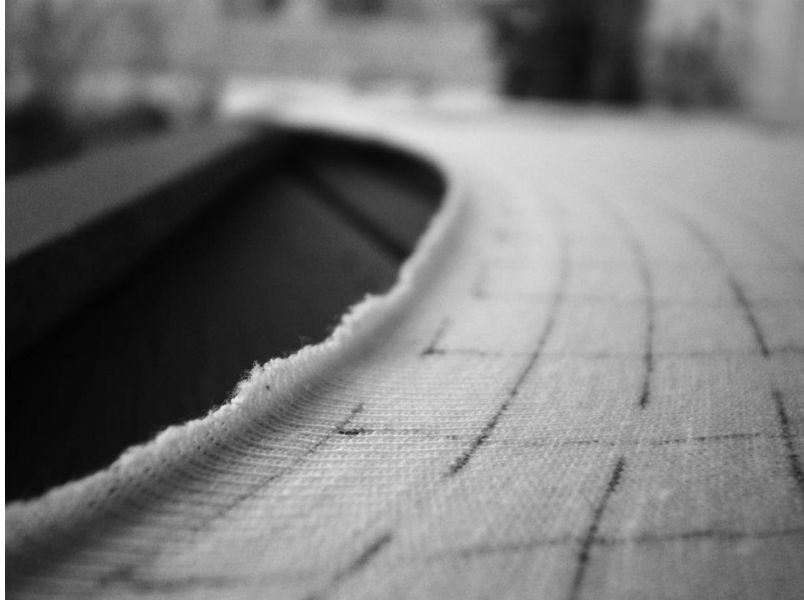
The first situation is a cut on the frame. The edge of the textile at the missing frame is wrinkled and behaving like a perimeter cable. This cable balances the structure. When a cable is stitched to the edge

*Figure 1: Wrinkled edge*

The connection of the wrinkles and the perimeter cables is demonstrated with the frame examinations. The edge of the textile is stretched to 180°. The tension from this stretching wrinkles the edge, and the edge transforms to a new shape. The tension is the distribution load for the edge. If the distribution of tension has the same value at each point, the direction of the stress vector is perpendicular to the tangent of curved edge. The theoretical shape of the edge would be a semi-circle, but the deformed lines affect the distribution of the stress vectors, therefore the new shape differs from a perfect arch.

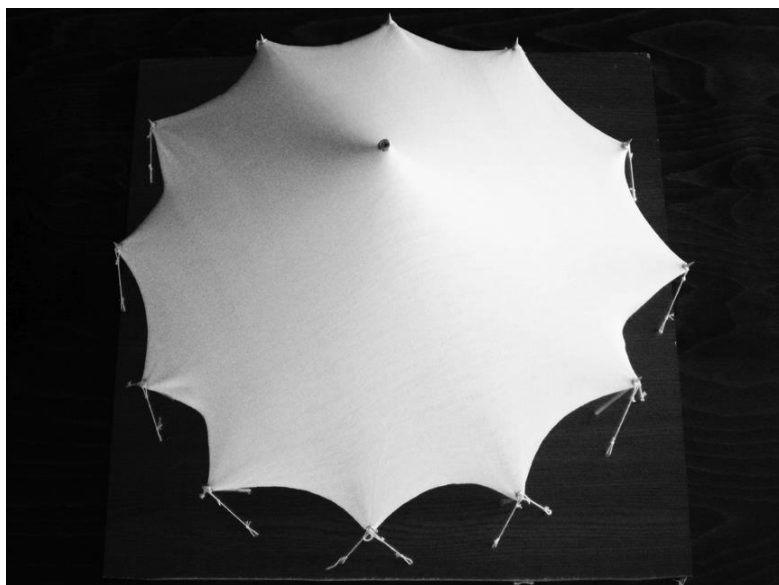
In architecture, the most common tensile structures are tents. Tents are more complex than frames and suitable to examine the wrinkles. The tent stands on a plywood board with pin-joint connections. A fabric material is stretched above a regular polygon between the central pole and the corners. There is a column and two cables in each corner.

*Figure 4: Tent with 12 corners*

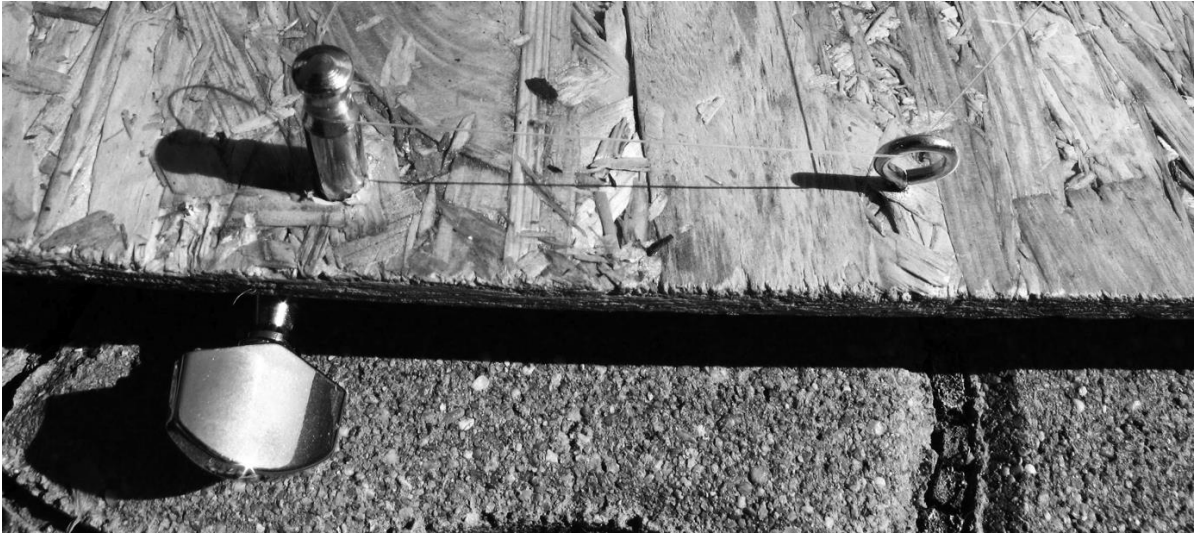
*Figure 10: One of the guitar tuners*

Making the appropriate distribution of tension is important. The guitar tuners enable us to increase the tension in the cables gradually and simultaneously. Otherwise other balanced situations could occur with inadequate (usually assymmetric) shape. These shapes often come with winkled parts, so they are inadequate to examine the wrinkling at the failures. Different shapes can have the same value of tension in the cables and compression in the middle pole. However the behaviour of these shapes are inappropriate in loaded situations.

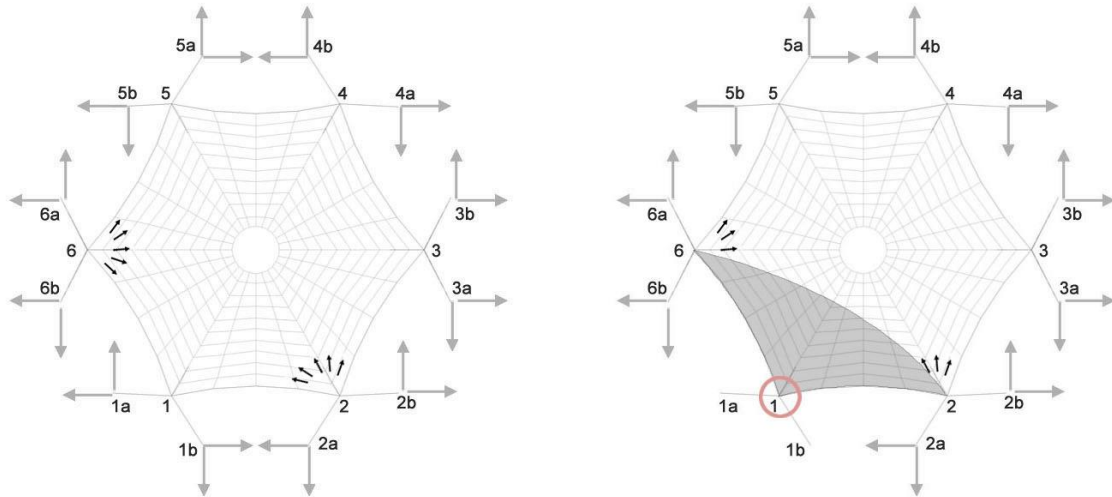
Figure 11: Before and after removing a corner

A missing corner is increasing the stress in the next and the previous cables. When a corner is removed, the cables next to it lose the corner's support. As a result, the wrinkle is a connecting catenary curve between the corners next to the removed corner.

Removing more than 1 corner is similar. For example: removing '1' and '4'. In this case, the heavily stressed cables are: '6b', '2a', '5a', '3b'. The wrinkles are running from '6b' to '2a', and from '5a' to '3b'.

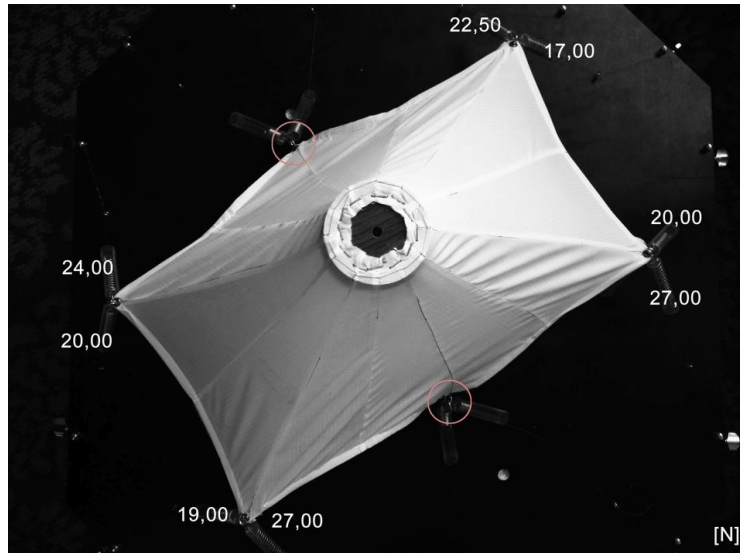
Figure 13: 2 missing corners

Initially, there were 25N in the spring balances. The wrinkles are quite noticeable. They start from the heavily stressed corners, but the stitched connections are too rigid to transmit them, therefore most of the wrinkles break at the first stitched connection.

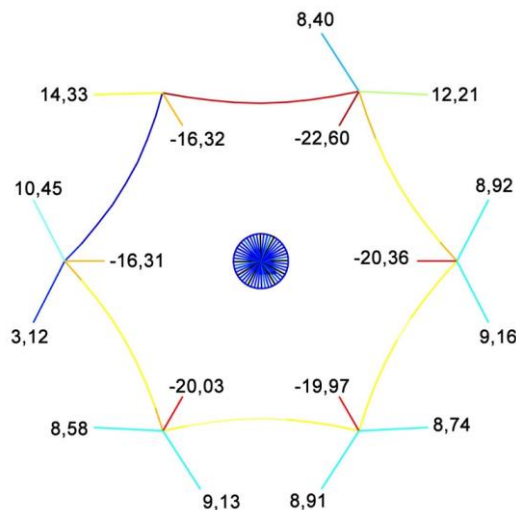
If a cable is removed from a corner, its pair has to take heavier loads. The corner moves to the side. For example: '1a' is removed. '1b' become a heavily stressed cable. The corner moves to the left and this movement tense '6b' and decrease the stress in '2b'.

Figure 14: 1 removed cable

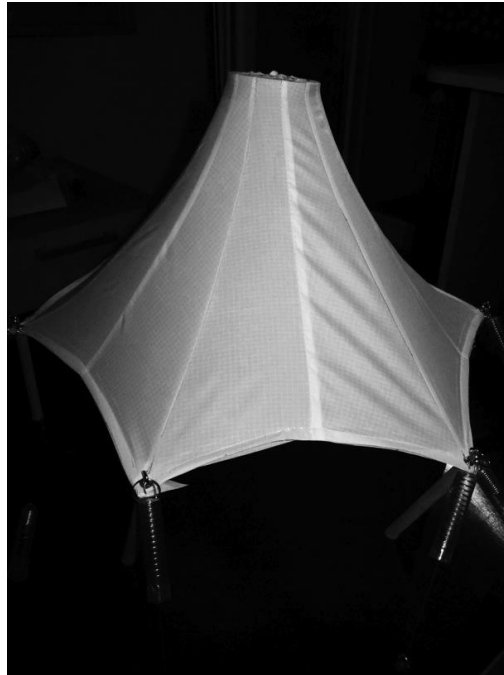
If the 2 cables are not in the same corner, they behave similar to the 1 removed cable situation. The corners move from each other to the another direction.

Figure 15: 2 removed cables next to each other
