### Analysis of the applicability of optical fibers as sensors for the structural health monitoring of polymer composites: the relationship between attenuation and the deformation of the fiber

Gergely Hegedűs<sup>1</sup> and Tibor Czigány<sup>1,2\*</sup>

<sup>1</sup> Department of Polymer Engineering, Faculty of Mechanical Engineering, Budapest University of Technology and Economics, H-1111 Budapest, Műegyetem rkp. 3. Hungary

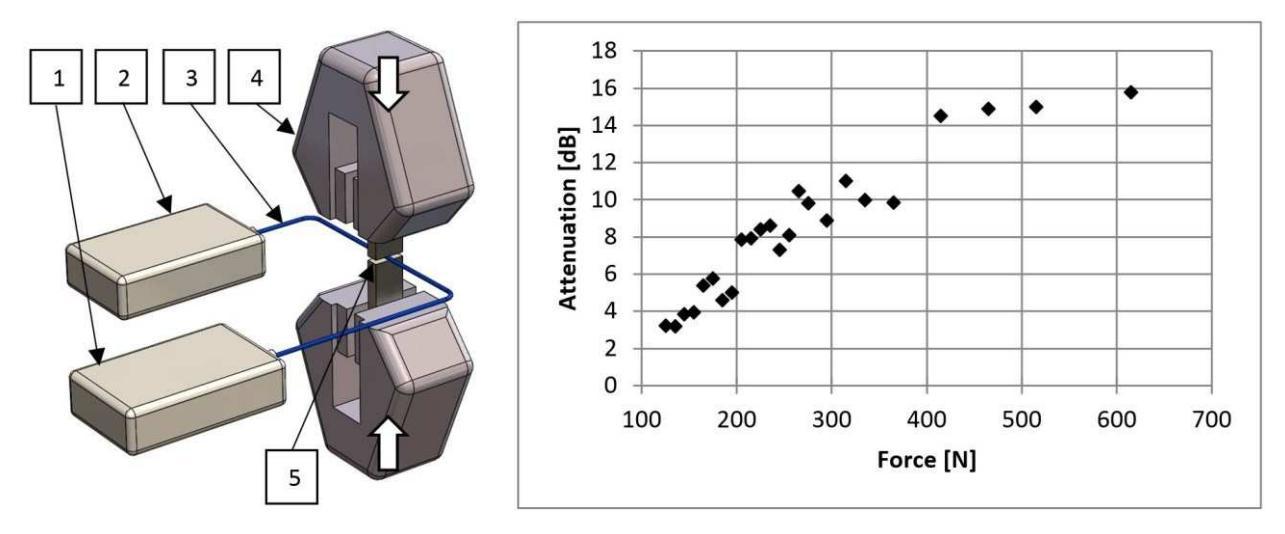
Fig. 1. Compression test layout (1-light source, 2-attenuation meter, 3-optical fiber, 4-clamps of the tensile tester, 5-flexible compression plate) and a typical curve

In our first experiment, we examined how the attenuation of optical fibers changes as a result of compression perpendicular to the axis of the fiber. Since the fiber is sensitive, fibers were compressed with a flexible compression plate until breakage, in order to avoid immediate breakage. The various compressive force values and the corresponding attenuation values can be found in Fig. 1.

The measured values show that the attenuation of the fiber increases as the compressive force increases. A 10 N increase in compressive force leads to an attenuation change of several tenths of decibels (this change can be measured well because it is similar to the attenuation of a mechanical optical coupler). The measurement shows that the procedure can indicate changed compressive force and the deformation of the fiber but it cannot show the location of the deformation. If deformation causes the fiber to break, light cannot travel further in the fiber and will not exit at the testing side (it exits the fiber earlier at the point of breakage), therefore the method can show extreme deformations and failures that cause the fiber to break.

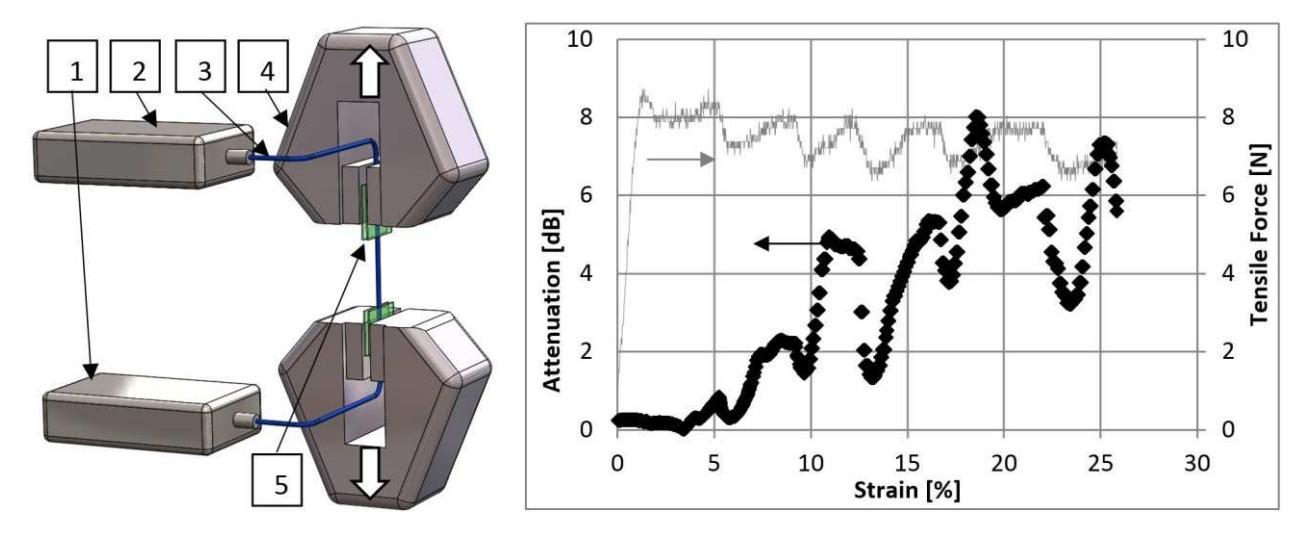
## Fig. 2. Tensile test layout (1-light source, 2-attenuation meter, 3-optical fiber, 4-clamps of the tensile tester, 5-tabs) and a typical curve measured with the coated fiber slipping out

We measured the change in the attenuation of optical fibers during tensile loading; the specimen was tabbed to avoid slipping out. 50 mm of free length was left between the tabs. The measurement layout can be seen in Fig. 2. When the specimens were clamped, the pressure of the clamps of the tensile tester clearly caused an increase in the measured attenuation values.

The coated optical fiber slipped out from between the two composite plates used to clamp it, due to the inferior adhesion of the matrix and the coating, therefore we get different pulling force – attenuation values as a function of relative displacement. On the pulling force – displacement diagram it can be seen that the fiber slips at times but the attenuation of the fiber still increases as the tensile force increases. This phenomenon shows that attenuation is related to the deformation of and the tensile stress in the fiber.

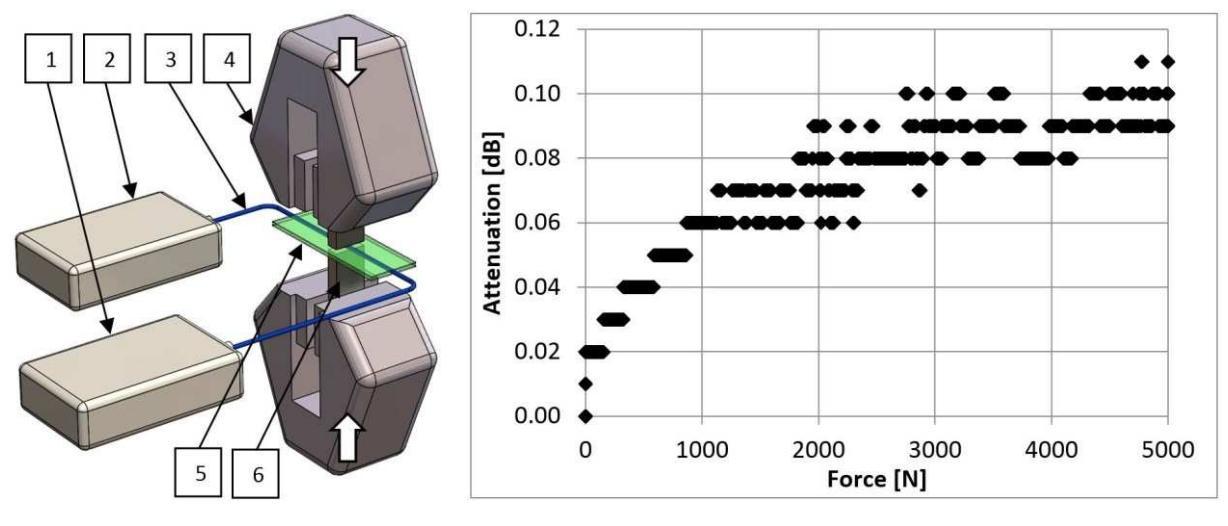
*Fig. 3. Compression test layout (1-light source, 2-attenuation meter, 3-optical fiber, 4-clamps of the tensile tester, 5-composite specimen, 6-compression area) and typical curve*

In order to investigate the change in the health of composite parts, we made a 140 mm long specimen, with an optical fiber between two layers of [0/90] woven glass fiber mats, and examined the change in the attenuation of the fiber, while continuously increasing compressive force (Fig. 3).

The compressive force – attenuation diagrams show that the attenuation of a fiber embedded into a composite specimen increases as the compressive force increases, but not as much as in the case of a standalone optical fiber. The reason is that the glass fiber mat surrounding the fiber distributes the load and the optical fiber does not take the entire load.

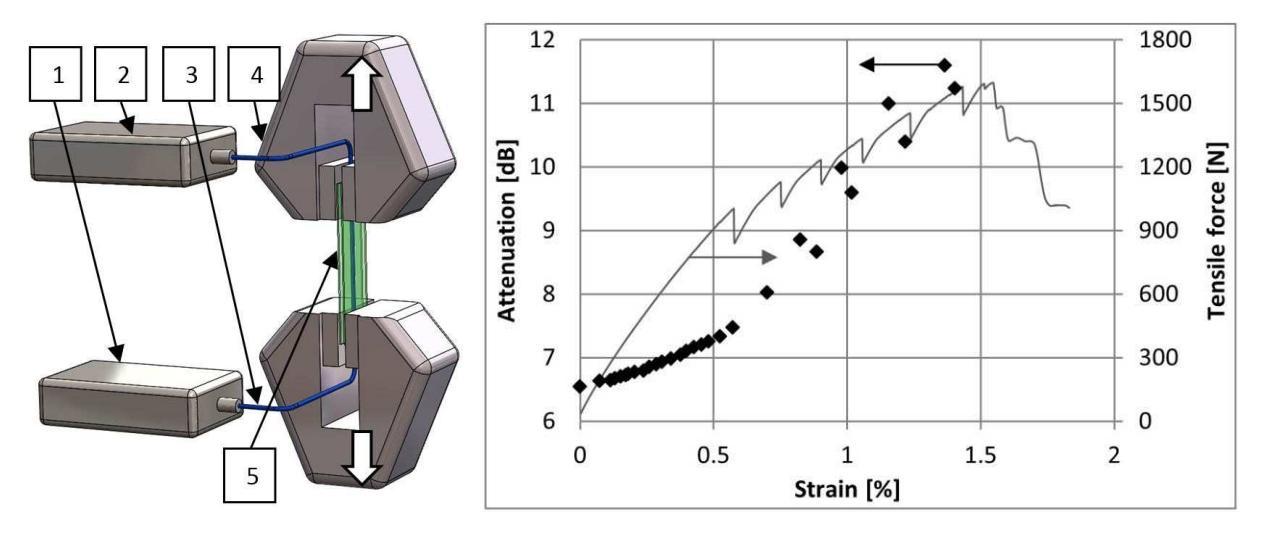
*Fig. 4. Tensile test layout (1-light source, 2-attenuation meter, 3-optical fiber, 4-clamps of the tensile tester, 5-composite specimen) and a typical curve*

The previous tests (3.1.2.) showed that the strain of a standalone optical fiber caused by a tensile force changed the attenuation of the fiber. The goal of our next set of experiments was to show that the attenuation of an optical fiber embedded into a composite specimen also changes as a result of deformation caused by a tensile force. We made a 140 mm long specimen, with an optical fiber between two layers of [0/90] woven glass fiber mats, and examined the change in the attenuation of the fiber as a result of tensile loading (Fig. 4).

During the tensile test of the composite specimen, we continuously measured the attenuation of the embedded fiber and the amount of loading. The initial distance between the clamps of the tensile tester was 70 mm. After clamping, the initial attenuation of the fiber increased by 6.55 dB. The results show (Fig. 4) that with the deformation of the composite specimen, and thus the embedded optical fiber, the attenuation of the optical fiber increases. Up to a strain of ~0,6% the attenuation of the fiber increased by ~1 dB (a ~20% reduction in the power of the emitted light), then attenuation increased faster, at a strain of ~0,8%, attenuation increased by ~2,3 dB compared to the initial value (a ~41% reduction in the power of the emitted light). This change in attenuation can be identified and provides help in identifying a load that is too high, before catastrophic failure of the specimen. The disadvantage of the measurement layout is that the fiber enters and exits the specimen beyond the clamps of the tensile tester, therefore the optical fiber suffered a high load during clamping, which lead to an increase in the initial attenuation values. The increase in attenuation was an order of magnitude higher than in the case of the compressive test of the previous composite specimen. The explanation is the fastening of the optical fiber in the composite. The optical fiber ran on the surface of the specimen in some areas where the specimen was clamped and there the compressive force of the clamps loaded the fiber directly. This may have influenced the measurement results, therefore we decided on a new specimen, which eliminates this measurement error.

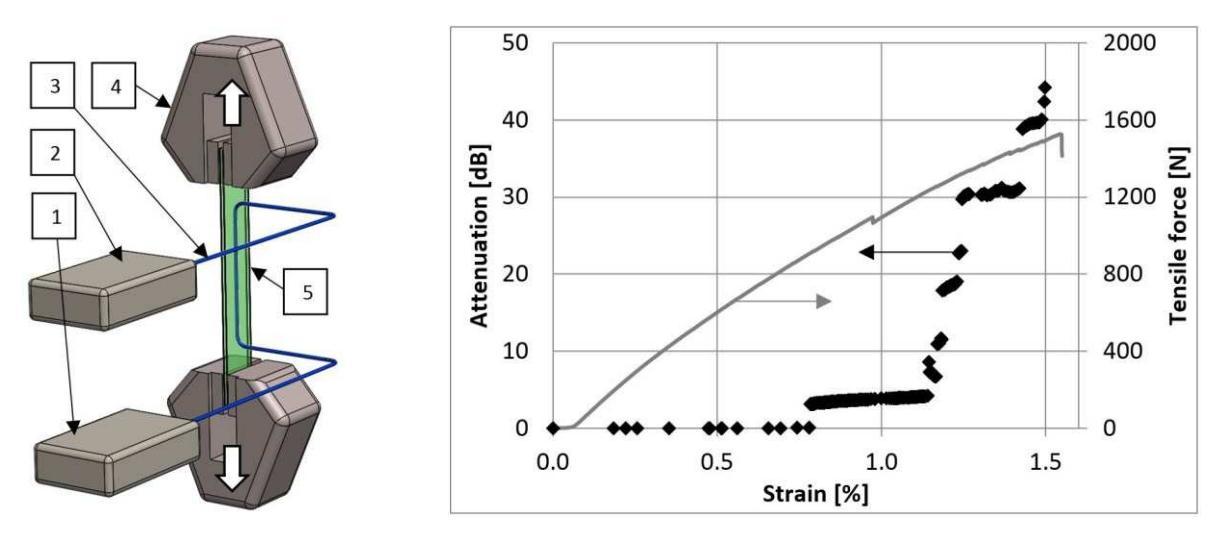
*Fig. 5. Tensile test layout (1-light source, 2-attenuation meter, 3-optical fiber, 4-clamps of the tensile tester, 5-composite specimen) and a typical curve*

woven glass fiber mats with an optical fiber between them in such a way that the optical fiber exits the specimen before the clamps of the tensile tester, so the fastening of the specimen does not influence the measured values. The full length of the specimen is 250 mm, clamping length is 185 mm, the embedded length of the optical fiber is 140 mm. Attenuation after clamping was 0 dB. We measured the change in attenuation while a tensile force was applied (Fig. 5).

The change in the attenuation of the optical fiber shows the applicability of the method very well. The fastening of the specimen did not affect the value of initial attenuation in any of the measurements, so we only actually measured the attenuation change caused by the tensile load. The attenuation change remained under 0.1 dB (a ~2.3% change in the intensity of the emitted light) up to a strain of 0.6%, but between ~0.6% and ~0.8% deformation, attenuation increases drastically. This sharp increase can be clearly identified and can be attributed to a deformation state. This deformation state is well below the value belonging to the catastrophic failure of the composite specimen (1.2%-1.5%). In the case of general-purpose composite structures, the method may be suitable to show deformation before catastrophic failure. During operation, if the change in the attenuation of the embedded optical fiber exceeds 1 dB (a ~20% reduction in the power of emitted light), it indicates that deformation is greater than 0.6%, therefore maintenance or another check is necessary. The jump in attenuation did not show up in the previous test because of the increased attenuation of the fiber caused by clamping. For this reason, it is very important that optical fibers are embedded into composite structural elements carefully and without loading.

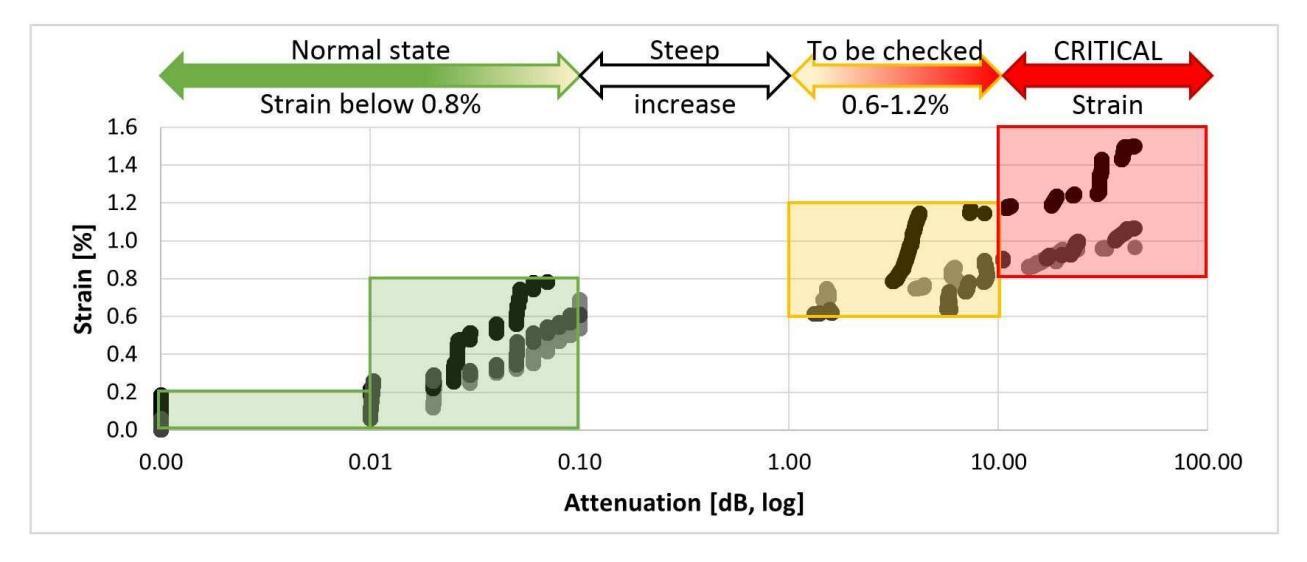
Fig. 6. Structural health according to the measured values

The figure shows that below a 0.01 dB attenuation, the strain of the structure does not exceed 0.2%, between an attenuation of 0.01-0.1 dB the strain of the structure is less than 0.8%, and above this, a strain increase causes a huge jump (more than an order of magnitude) in attenuation. An attenuation of more than 1 dB indicates that the strain of the structure has exceeded 0.6%, and it is necessary to perform an additional structural health check at the location of the fiber. If attenuation exceeds 10 dB, the structure has reached a state of critical deformation and is only 0,3-0,4% strain away from critical failure – immediate action is required.

provides a clear indication of a strain of 0.6-0.8%. In the case of general-purpose polymer matrix composites, where knowing the structural health of the product is not critical but important, and low cost is essential, therefore complex, embedded sensors cannot be used, our method is a suitable alternative. It is cheap and shows deformation before critical failure. The method can be put into practice easily, thanks to the advantageous properties of optical fibers, and the easy availability of attenuation metering equipment. The simplicity of application is shown in Fig. 6. The method can provide the information whether or not a more thorough structural check is necessary.
