Metal-alike polymer composites: The effect of inter-layer content on the pseudoductile behaviour of carbon fibre/epoxy resin materials Magyar B., Czigány T., Szebényi G.

Metal-alike polymer composites: The effect of inter-layer content on the pseudo-ductile behaviour of carbon fibre/epoxy resin materials

With interfacially engineered pseudo-ductile carbon fibre reinforced polymer composites, a higher energy absorption capacity and metal-like stress-strain response can be achieved during failure. Due to incorporated interlayer additives deposited with fused filament fabrication, locally weakened zones can be printed on the surface of the reinforcing material, which provides better energy absorption capability during the composite laminates' damage process by the alteration of crack propagation. The reason for this phenomenon is that cracks near the inter-layered zones require more energy to propagate, which delays the onset of final failure in the form of local damage. The modified layers are then infiltrated with an amine-cured epoxy by vacuum assisted infusion. The change in pseudo-ductile behaviour as a function of the interfacial additive content was investigated, along with t

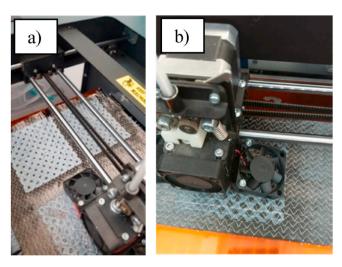
Fig. 2. 3D printing of the interfacial patterns onto the surface of the UDCF; a) Biaxial grid, SF = 87.5%; b) Biaxial grid SF = 50%.

Following surface grid printing (Fig. 2), preforms were prepared for

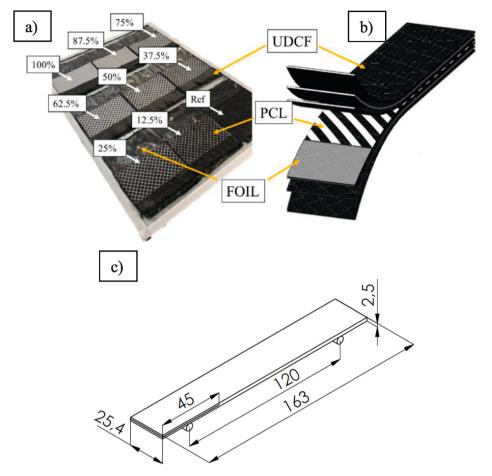
Fig. 3. ENF specimens; a) Preparation of the ENF specimens with various PCL contents for vacuum infusion; b) schematic structure; c) specimen with its dimensions.

During the manufacturing of end-notched flexure (ENF) specimens, an artificial defect was placed between the predetermined layers (with the help of a foil, resulting in artificial layer separation between the 3rd and 4th layer of the 6-layer composite), thus mode II failure mode

(Fig. 3) could be examined. Interlaminar fracture toughness values were examined while the PCL ratio was varied. Test speed was 5 mm/min, the distance between the supports was 120 mm. Specimen length, width and thickness were 163 mm, 25.4 mm and 2.5 mm, respectively. Artificial delamination length was 45 mm.

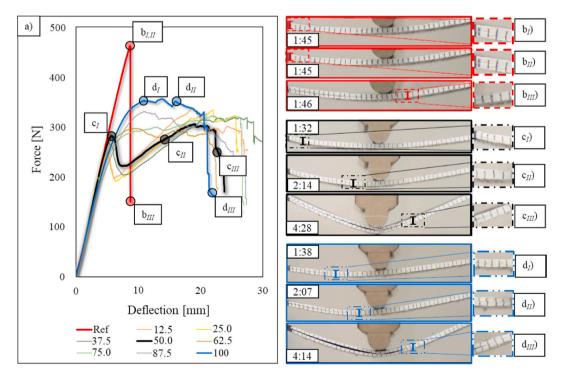
Fig. 4. a) Specific ENF test bending force–deflection response; Crack propagation at different surface filling contents, where the I index shows the moment at G_{IIc} , the II index shows the halfway time between G_{IIc} and final failure, and the III index shows the moment after failure with a twice magnified view from the crack propagation front; b) Reference specimen; c) 50% sf content; d) 100% sf content.

As the ENF bending force-deflection curves (Fig. 4) indicate, the presence of PCL in the specimens reduces the first force peak. The most significant decrease occurred in the sample with the lowest PCL ratio (12.5%). As the SF ratio was increased, the force also increased after the initial drop and approached the neat sample's value. The force peaks appeared with increasing deflection as the PCL ratio increased. The increase in deflection can be attributed to the presence of the PCL, where the crack propagation rate slows down (slower than in the reference sample) when the crack encounters the locally modified printed zone. At low SF ratios, well-separable force peaks occurred. However, in samples with a higher PCL ratio, a plateau forms, and crack propagation is gradual. The plateau also indicates gradual failure, with the crack spreading more evenly than in the case of the neat samples. This gradual damage progression also appears in the photos taken during failure (Fig. 4 b; c; d). In the case of the neat reference sample, the G_{IIc} values appeared at the maximal load and immediately after reaching this point, failure appeared with sudden crack propagation. In the moment before failure, there was no visible crack on the side of the specimen but in the moment after G_{IIc} was reached, failure appeared with a sudden crack front spread. In case of the modified samples (SF = 50; 100%; Fig. 4. c; d), after G_{IIc} was reached, crack propagation did not show a sudden spread without a resistance—there was gradual, stable propagation. The improvement in crack propagation can be observed in Fig. 4 c_{II} and d_{II}, where the crack front still spread after the $G_{\mbox{\scriptsize IIc}}$ value was reached.

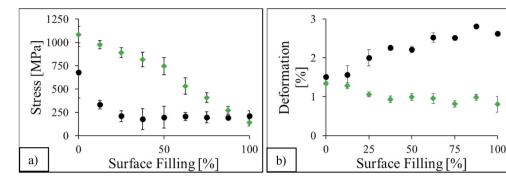
Fig. 9. Results of the 3-point bending test at different surface filling ratios (●-Maximal values, ◆-breaking values); a) Stress values; b) Deformation values.

However, there is a downward trend of the maximum strength values (σ m) even at lower fill levels, but a significant decrease occurs at 50% surface fill (95% probability based on ANOVA). Reference specimens failed without further significant deformation at maximum load (Fig. 9). The deformation values at maximum stress (ϵ_m) have gradually decreased due to the phenomenon mentioned above, which also appears in the modulus values. The behaviour of the composites at fracture also differs significantly with increasing surface fill. The breaking stress values decreased (σ_b), and more significant deformation allowed the composites to absorb more energy.

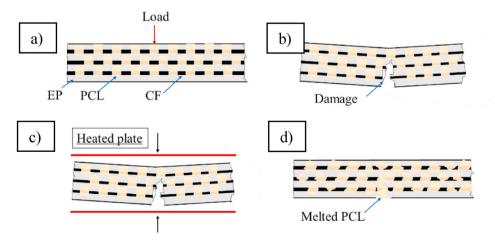
Fig. 11. The process of repairing the broken samples after the 3-point bending test; a) Initial state; b) damaged specimen; c) repair with heat and pressure; d) repaired specimen.

The PCL grids could repair the damaged or even collapsed composite specimens when melted. When melted (Fig. 11), the PCL could fill the

damaged areas acting as a repairing agent. At the cracked areas, the PCL would act as a new resin by filling the gaps caused by the damage created during the three-point bending test. The repair process was carried out with the same Teach-Line Platen Press 200E with a pressure of 4.5 MPa for 1 min and a temperature of 100 $^{\circ}$ C. After the repair process, the specimens partially regained their integrity, and we performed the bending tests again. The reference samples could not be repaired due to the lack of PCL.
